**Thermography Inspection of PV Module-Gut  
104 and 105" – Location- Dhamangaon,  
Dist.: Amravati**

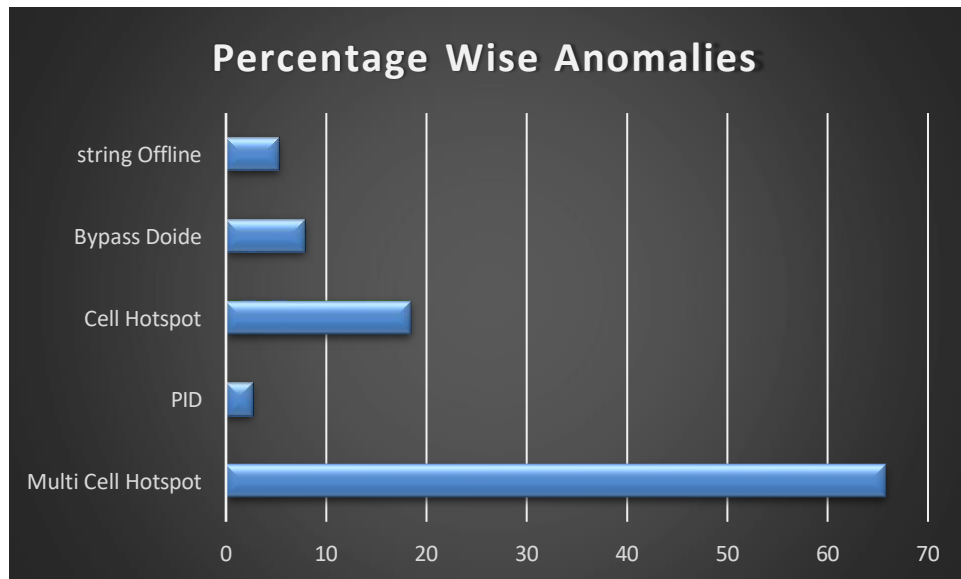
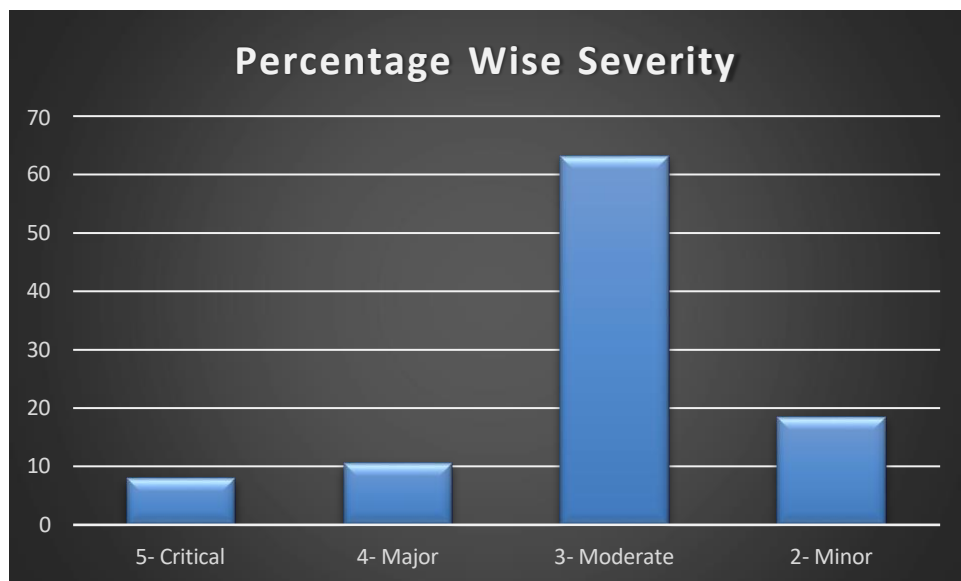
## STATISTICS OF ANOMALIES AND SEVERITY

Sr. No	Type of Defect	Total	Percentage
1	Multi Cell Hotspot	25	65.78947368
2	PID	1	2.631578947
3	Cell Hotspot	7	18.42105263
4	Bypass Doide	3	7.894736842
5	string Offline	2	5.263157895
		38	100

Sr. No	Severity Level	Total	Percentage
1	Severity 5- Critical	3	7.894736842
2	Severity 4- Major	4	10.52631579
3	Severity 3- Moderate	24	63.15789474
4	Severity 2- Minor	7	18.42105263
		38	100
